Manhole Inspection Summary

Manhole # **S33C__010MH**

Insp Date: **10/12/07 9:31 AM**

Location Address: **415 PARK AVE** Cross Street: **MULBERRY ST**

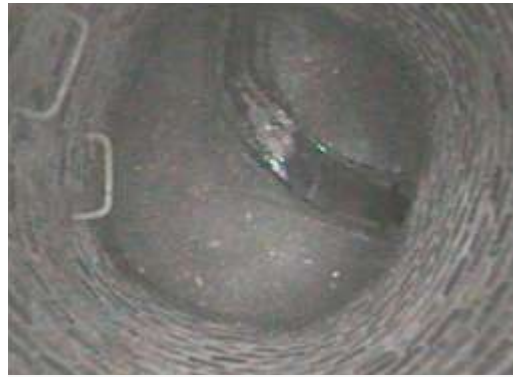
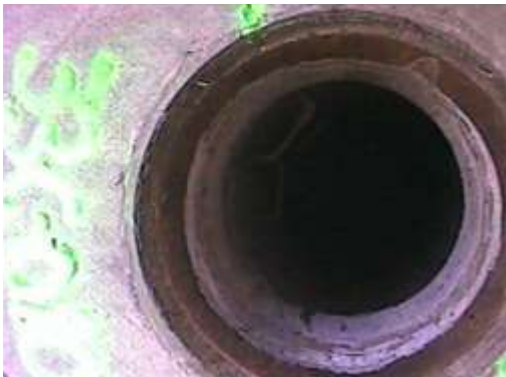
Top View

Condition: ☐ Sound ☐ Cracked ☐ Root Intrusion ☐ Deteriorated ☐ Leaks ☒ **Debris**

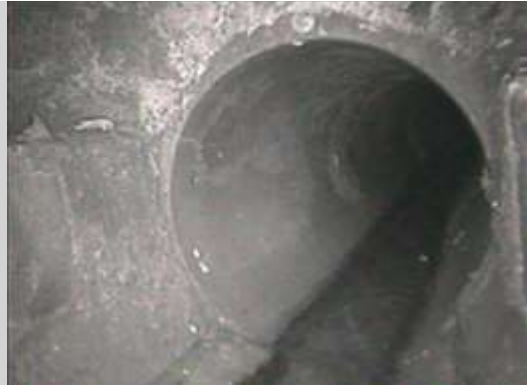
12 O'Clock Outflow

12 in. Circular Gravity Sewer
Pipe Out @ 12 O'Clock

Pipe Height: **8.4** (in.) Rod and Bar
Pipe Material: **Clay** ☐ Pipe Lined
Invert Depth: **14.98** (ft.) Flow Characteristics: **Slow**
Deposits: ☒ None ☐ Mud ☐ Sludge ☐ Debris ☐ Grease
Silt Depth: (in.) Deposits Extent:
Infiltration: **None** Pipe Seal Cond: **Sound**

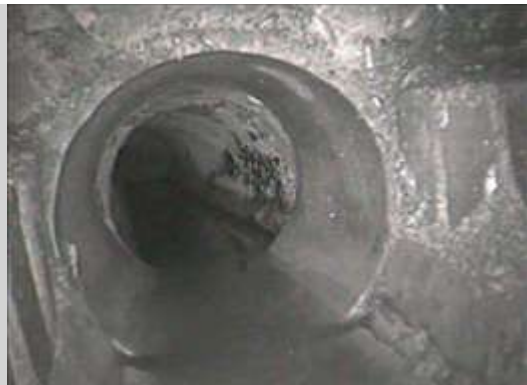
3 O'Clock Inflow

12 in. Circular Gravity Sewer
Pipe In @ 3 O'Clock

Pipe Height: **8.4** (in.) Rod and Bar
Pipe Material: **Clay** ☐ Pipe Lined
Invert Depth: **14.88** (ft.) Flow Characteristics: **Slow**
Deposits: ☒ None ☐ Mud ☐ Sludge ☐ Debris ☐ Grease
Silt Depth: (in.) Deposits Extent:
Infiltration: **None** Pipe Seal Cond: **Sound**
